Contract #: 04-0120F4Cty: SF/ALA Rte: 80 PM: 13.2/13.9File #: 69.28**WELDING INSPECTION REPORT****Resident Engineer:** Pursell, Gary**Address:** 333 Burma Road**City:** Oakland, CA 94607**Report No:** WIR-014863**Date Inspected:** 29-May-2010**Project Name:** SAS Superstructure**OSM Arrival Time:** 1900**Prime Contractor:** American Bridge/Fluor Enterprises, a JV**OSM Departure Time:** 700**Contractor:** Zhenhua Port Machinery Company, Ltd (ZPMC), Changxing Island **Location:** Shanghai, China**CWI Name:** See Below**CWI Present:** Yes No**Inspected CWI report:** Yes No N/A**Rod Oven in Use:** Yes No N/A**Electrode to specification:** Yes No N/A**Weld Procedures Followed:** Yes No N/A**Qualified Welders:** Yes No N/A**Verified Joint Fit-up:** Yes No N/A**Approved Drawings:** Yes No N/A**Approved WPS:** Yes No N/A**Delayed / Cancelled:** Yes No N/A**Bridge No:** 34-0006**Component:** OBG**Summary of Items Observed:**

On this date CALTRANS OSM Quality Assurance (QA) Inspector, Mr. Paul Dawson, arrived on site at the Zhenhua Port Machinery Company (ZPMC) facility at Changxing Island, in Shanghai, China, for the purpose of monitoring welding and fabrication of the San Francisco / Oakl

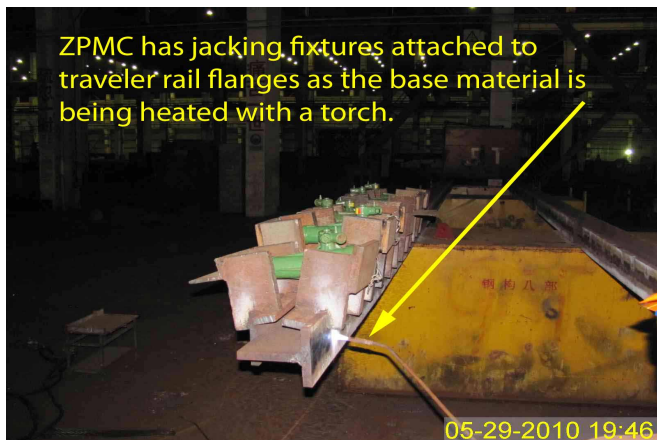
This QA Inspector observed ZPMC workers have recently been performing heat straightening the top and bottom flanges of traveler rail 20TR2-009 as listed on heat straightening document HSR1(B)-8350. ZPMC appears to have manufactured several brackets where mechanical jacks are being used to apply pressure to allow the top and bottom flanges to become parallel with each other. This activity is being monitored by ZPMC QC Inspector Mr. Shen Jian Guo who has a laser heat measurement device to monitor the temperature of the base material as it is being heat straightened. Items observed on this date appeared to generally comply with applicable contract documents. See the photograph below for additional information.
